CORROSION SURVEY OF STEEL SHEET PILING

27 December 1960

U. S. NAVAL CIVIL ENGINEERING LABORATORY
Port Hueneme, California

Type C Final Report

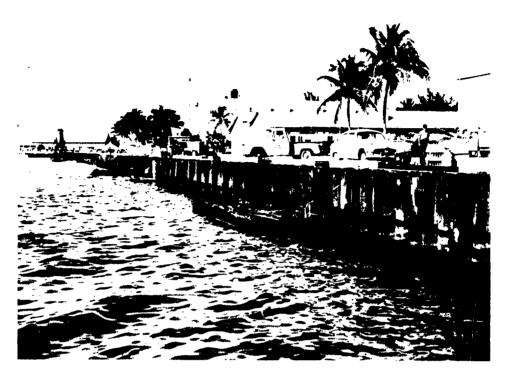
Figure 7. Key West quay test area.

Twenty samples were cut from the three piles at Key West. No samples could be obtained below the mud line because the piles were imbedded in coral. In the areas where the samples were cut, corrosion at inner corners had penetrated completely through the piling in the splash zone.

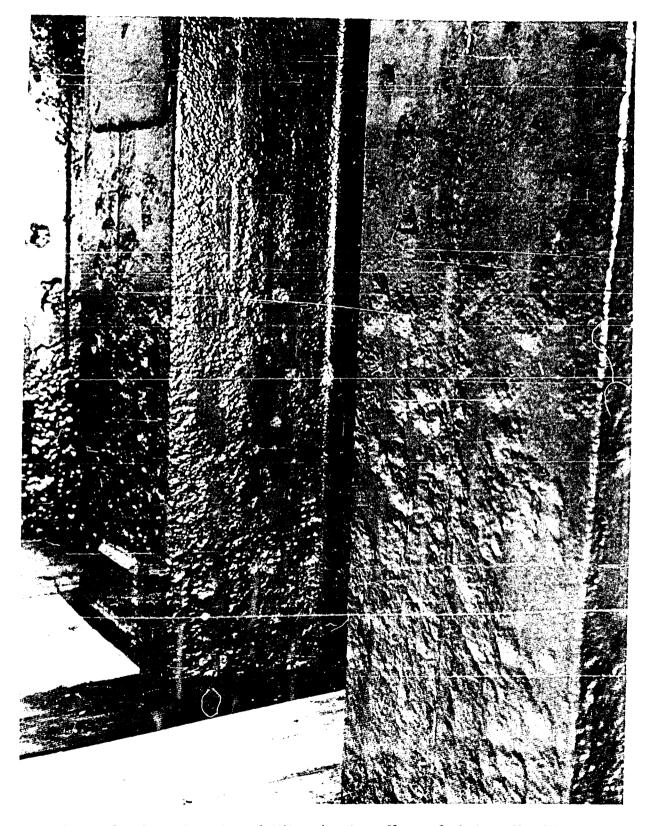
Figure 9. Coated section of piling showing effects of pitting, Key West.

Figure 9 shows a close-up of a section of the piling after the paint coating had been applied. The results of pitting can be seen in this photograph.

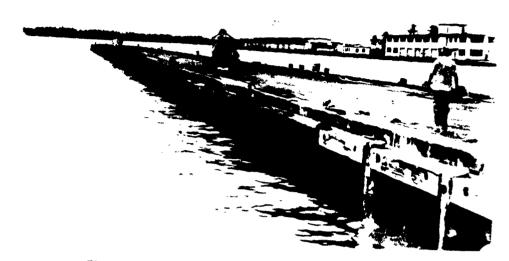
Figure 10. Pier No. 2, Coco Solo, Canal Zone.

Observations made at the time of cutting the samples revealed that corrosion intensity on the piling progressed rather uniformly from inboard to the outboard end along the pier. Also above high water corrosion appeared severe. No attempt had been made to apply a protective coating to the piling during periods of low tide. Cathodic protection has not been used on this pier. However, from time to time the piling in the tidal zone have become coated with floating oil which appears to have retarded corrosion.

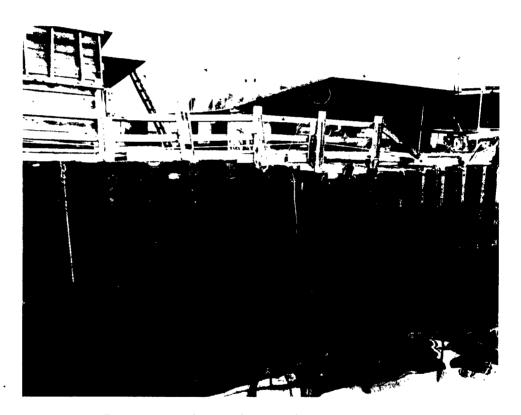
Figure 12. Sheet pile, wet basin, San Diego.

U. S. Naval Station, San Diego, California. The only area in the harbor using sheet piling is the "wet basin." Currently, this area is being used to bring in small craft from naval vessels; from the wet basin they are lifted up onto land and given a hull reconditioning. The harbor in this area is reported to receive discharge from sewage treatment plants and has little regular change of water other than that caused by tidal action.
